SEVENTH SEMIANNUAL STATUS REPORT
VOLUME II - APPENDIX A

ENERGY EFFICIENT ENGINE
COMPONENT DEVELOPMENT AND INTEGRATION PROGRAM

**ENERGY EFFICIENT ENGINE
HOLLOW FAN BLADES**

FINAL TECHNICAL REPORT

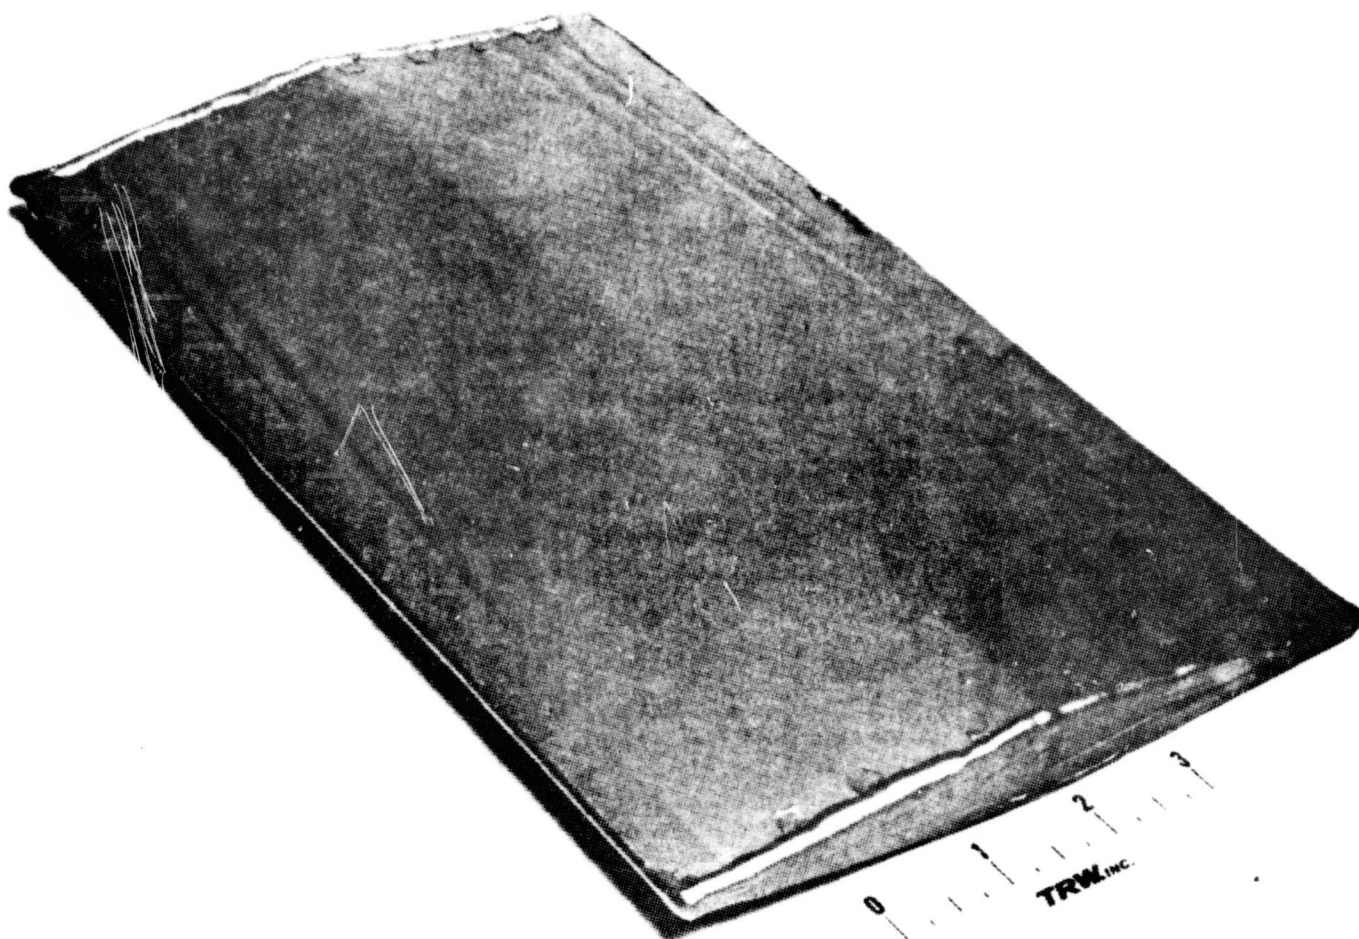
Figure 35. Solid Diamond Specimen (DS1) After Hot Isostatic Pressing. The Collapse of the Outer Ply Over the Ply Step Can Be Clearly Noticed. The Stain in the Right Hand Side is Probably Due to Some Contaminants in the Hot Gases During HIP.

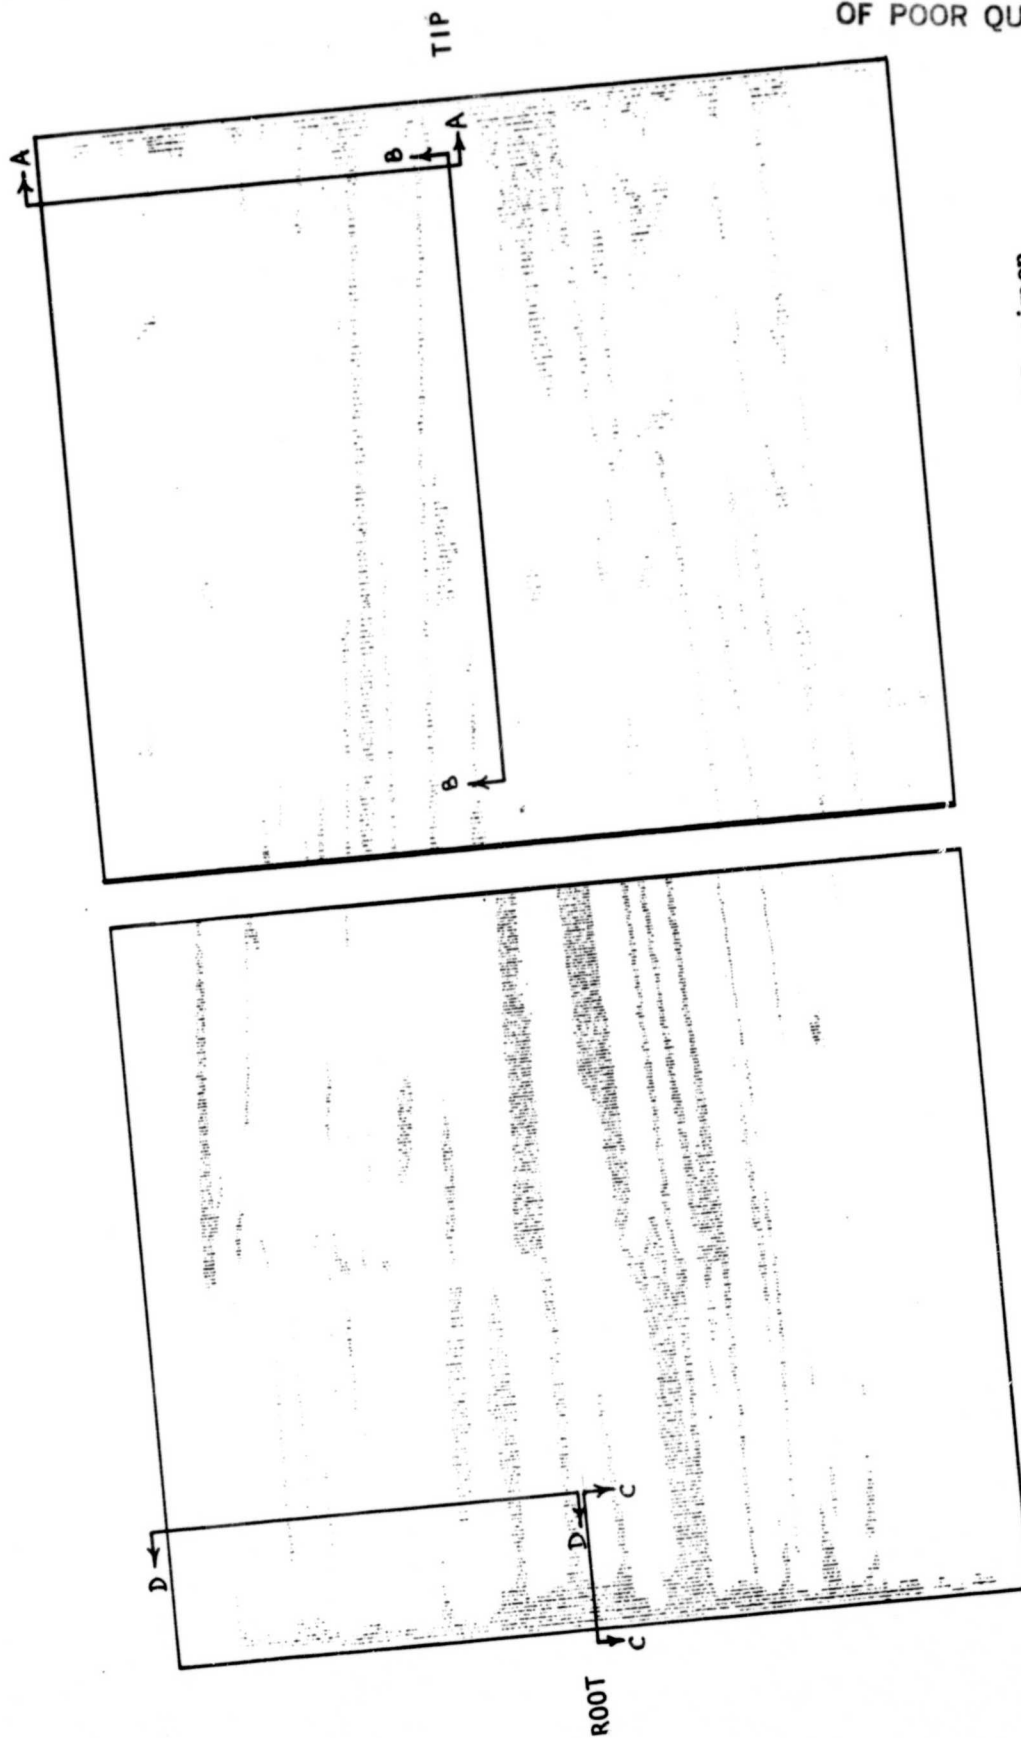
Figure 36.

Ultrasonic Through-Transmission C-Scan of Both Halves of Specimen DS1. The Shadows Shown Are Believed Caused by a Combination of Factors and Not by Delamination. The Sections Used for Metallography Are Indicated.

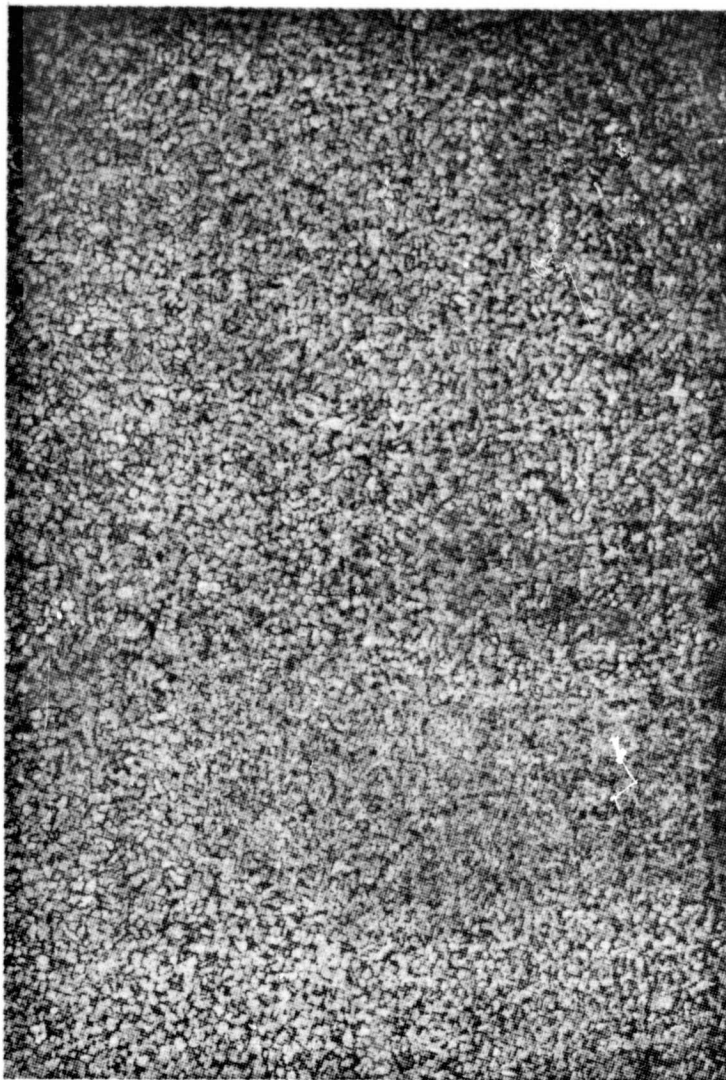
Figure 37. Microstructure of a Portion of Section AA (See Figure 36) of Specimen DS1. The Area of Noticeable Difference in Microstructure Seen in the Lower Portion represents What Used to be a Filler Strip at the End of a Ply. Such Variations in Microstructure Are One Possible Cause for the Shadows in the Ultrasonic C-Scan. Other Areas of Microstructure Variation Are Also Shown in Figures 38, 39 and 40.

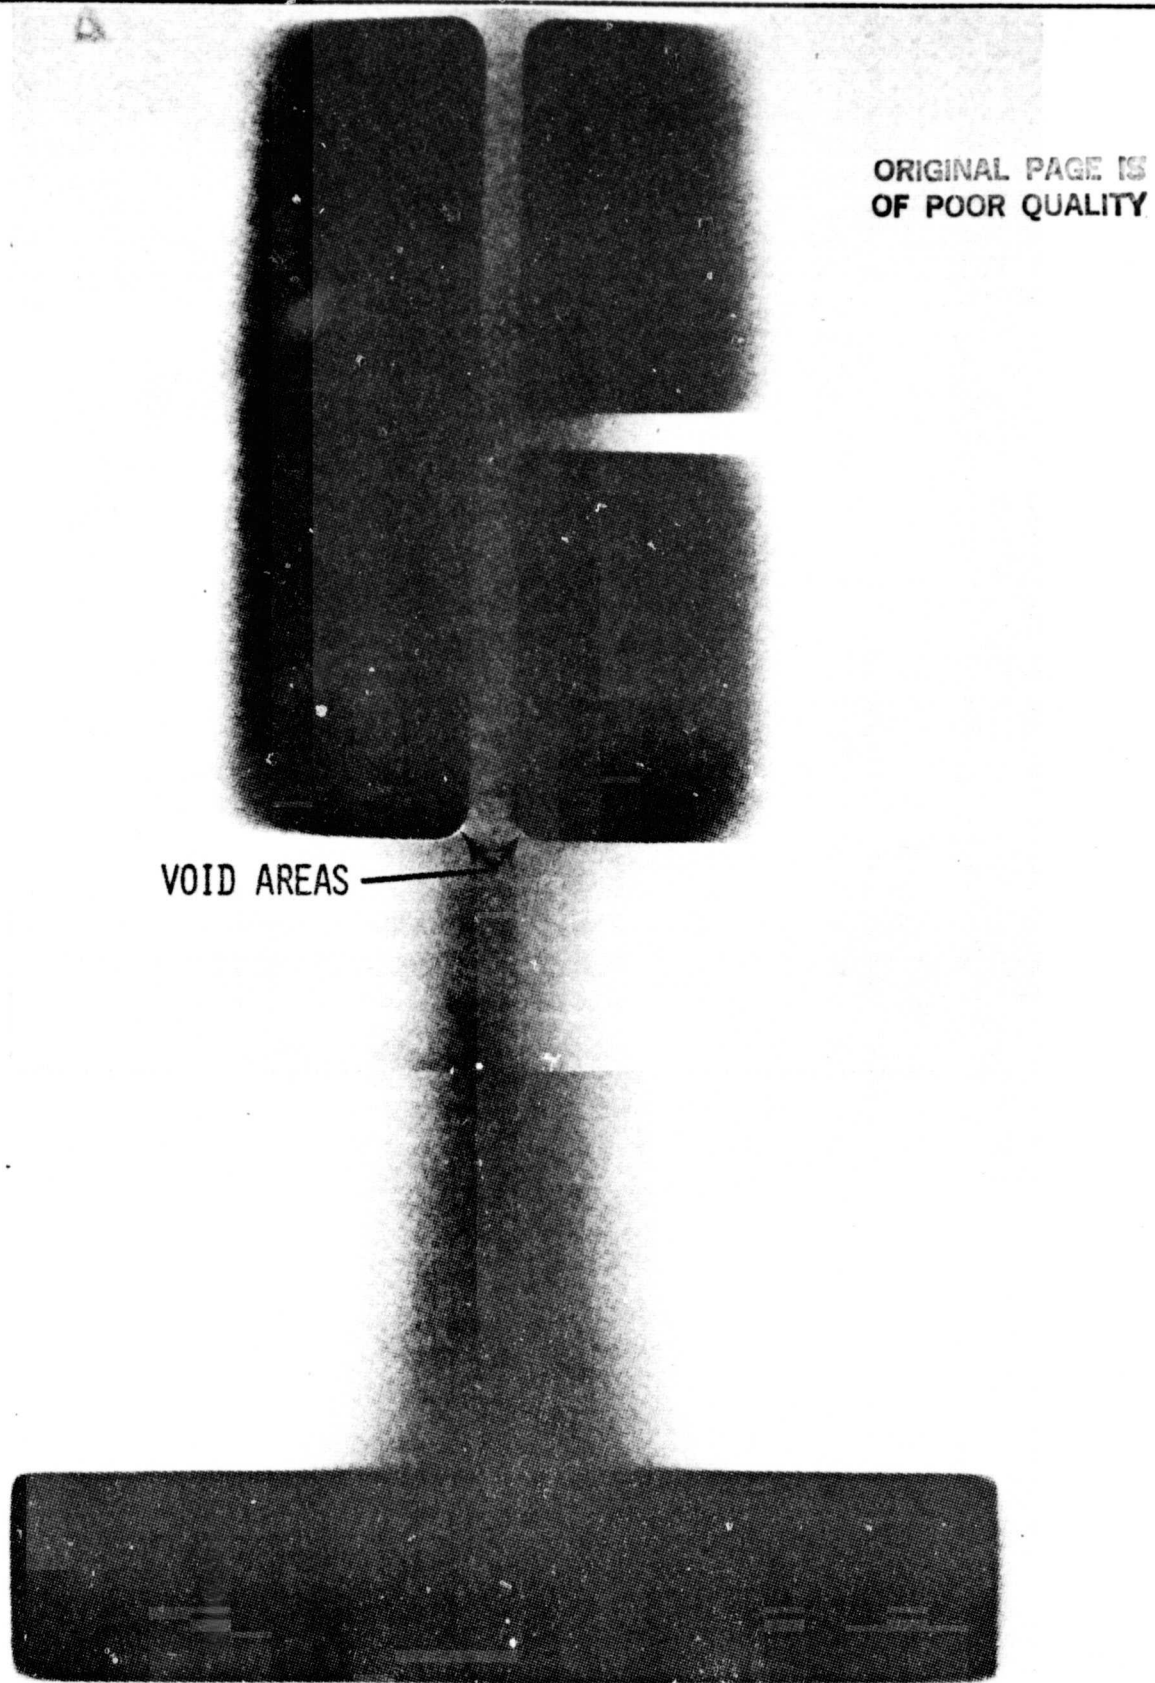
Figure 43. X-Ray of DS2. Note Lack of Fill at Core Ends.

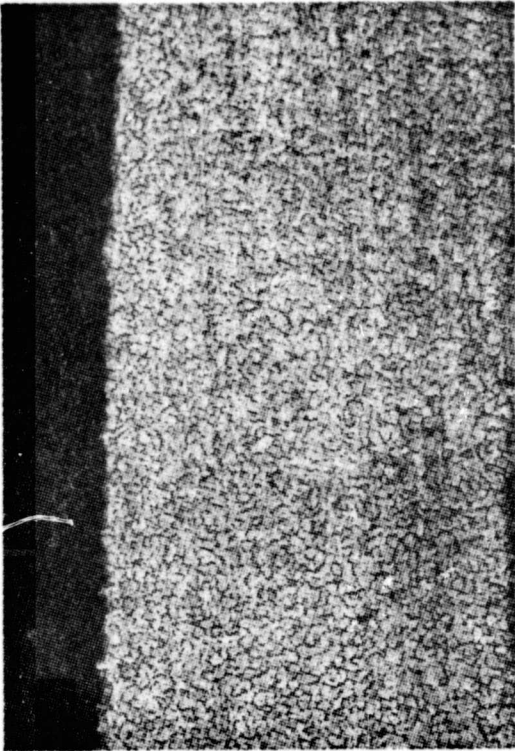
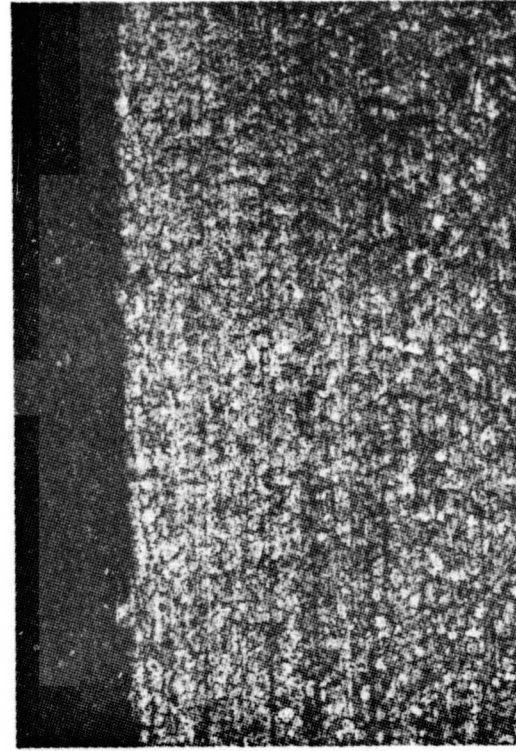
Figure 48. Surface Condition of Titanium After HIP Using Can Surface Treatment or Interfaces as Noted.

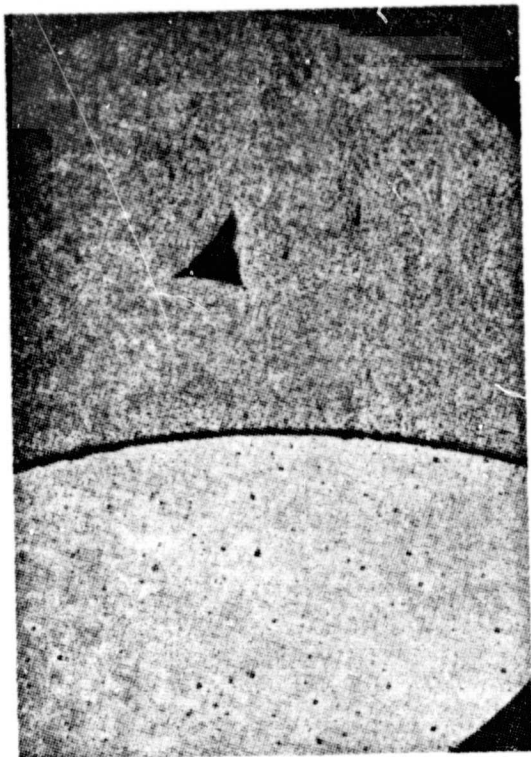
a. Trailing Edge (0.062-Inch Radius) 30X

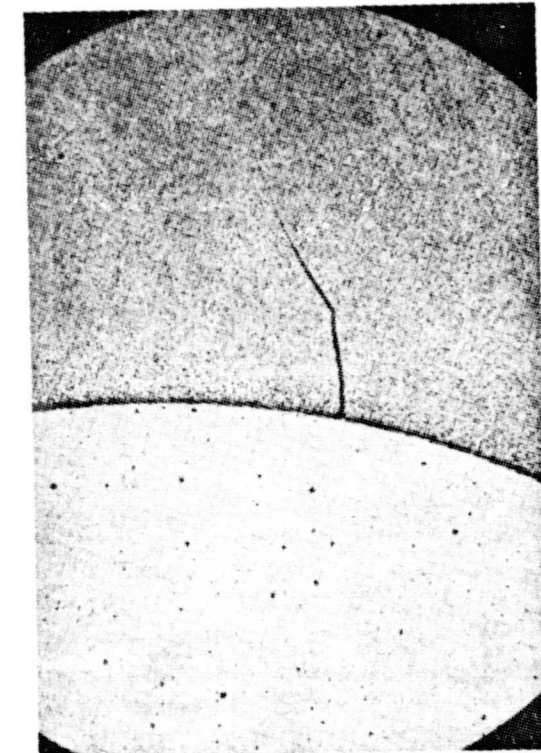
c. Crack Observed at Leading Edge 30X

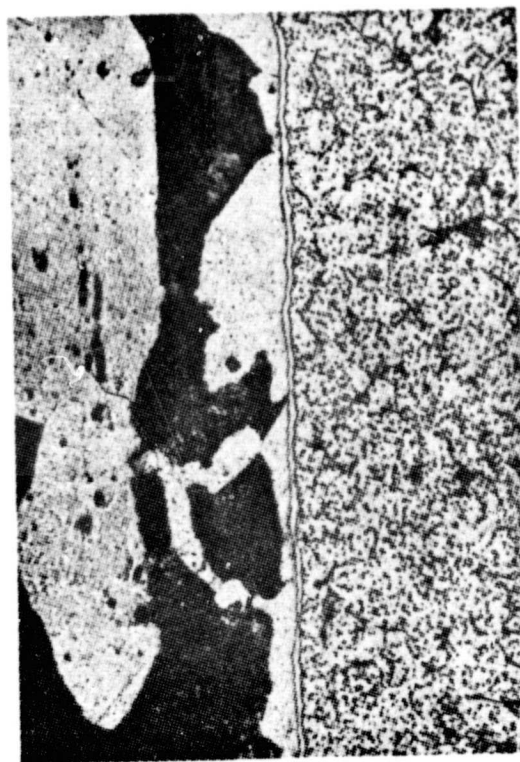
d. Reaction Zone 500X

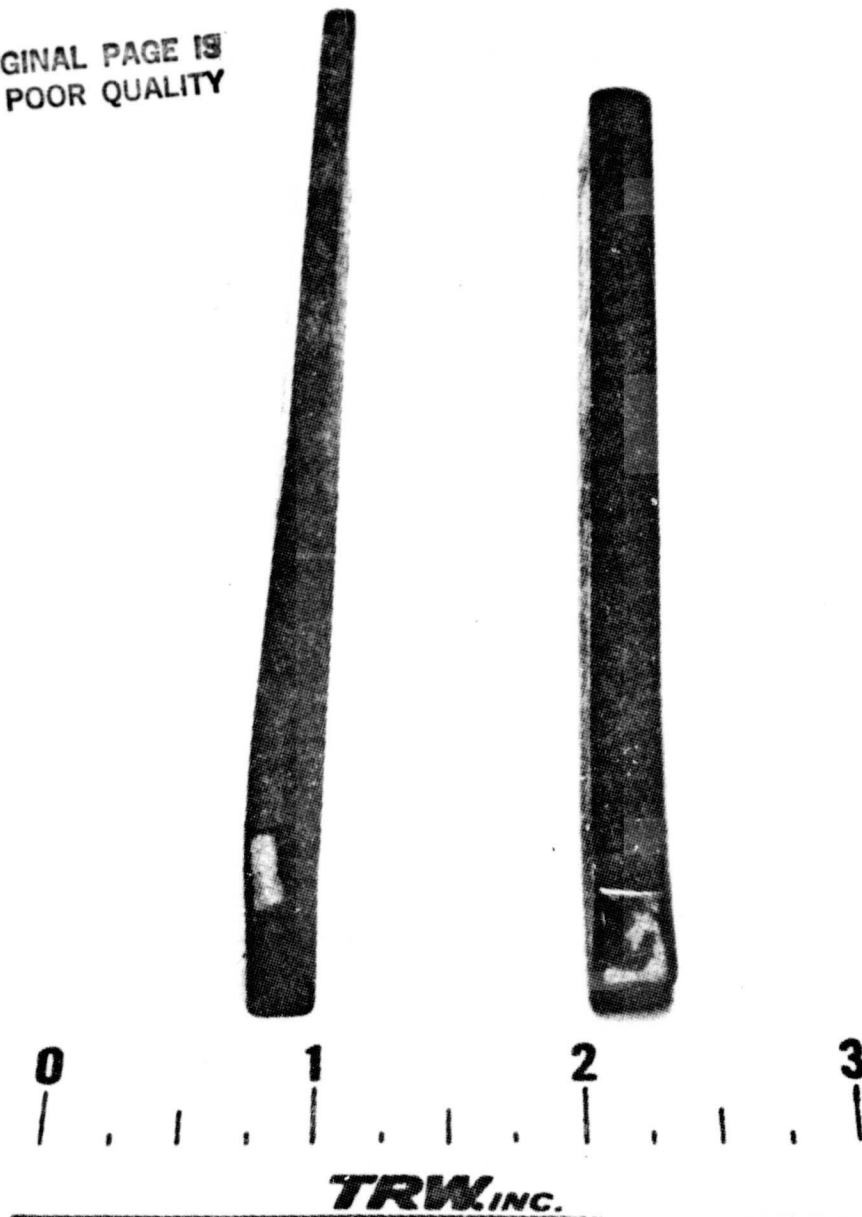
Figure 54. Edge View of Sectioned Core That Was Twisted. Twist Along Trailing Edge Radius Approximately 1° /Inch is Shown on the Left in Photograph.

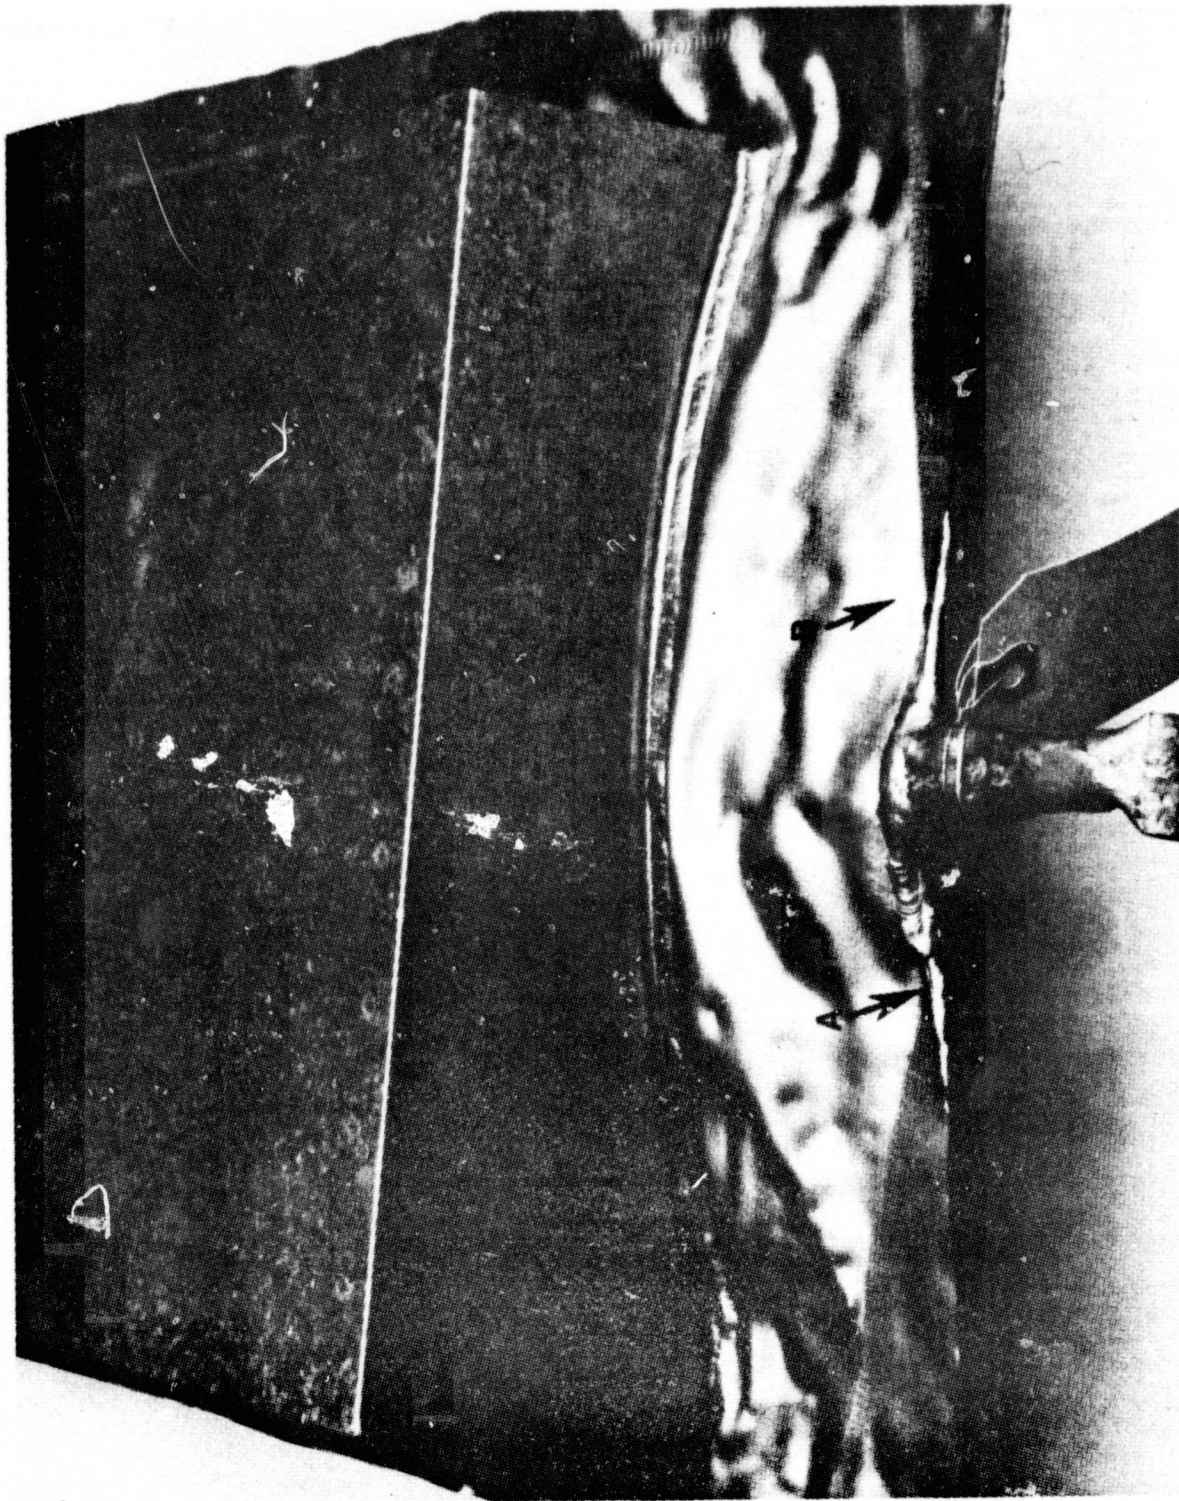
Figure 80. Closeup of Root End of HIP Blade Illustrating Location of Weld Failures.

A. TIG Weld Failure. B. Spot Weld Failure.

After can leakage in the first three blades, several process modifications to prevent failures in future HIP iterations were considered. For the rootless blade, filler material should be welded to the root end of the blade and a strip of material should be placed over this joint to prevent flow between the root end and filler material. It was also decided that a can sheet thickness of 0.060-inch would be more desirable than 0.030-inch. It appeared that TIG welding leads to problems with leaks during HIP. Instead of TIG welding the can sheet to the root blocks for blades with roots, the welding was to be accomplished by a combination of seam welding and overlapping spot welding. A simple fixture was built to accomodate the curvature of one root block for spot welding.

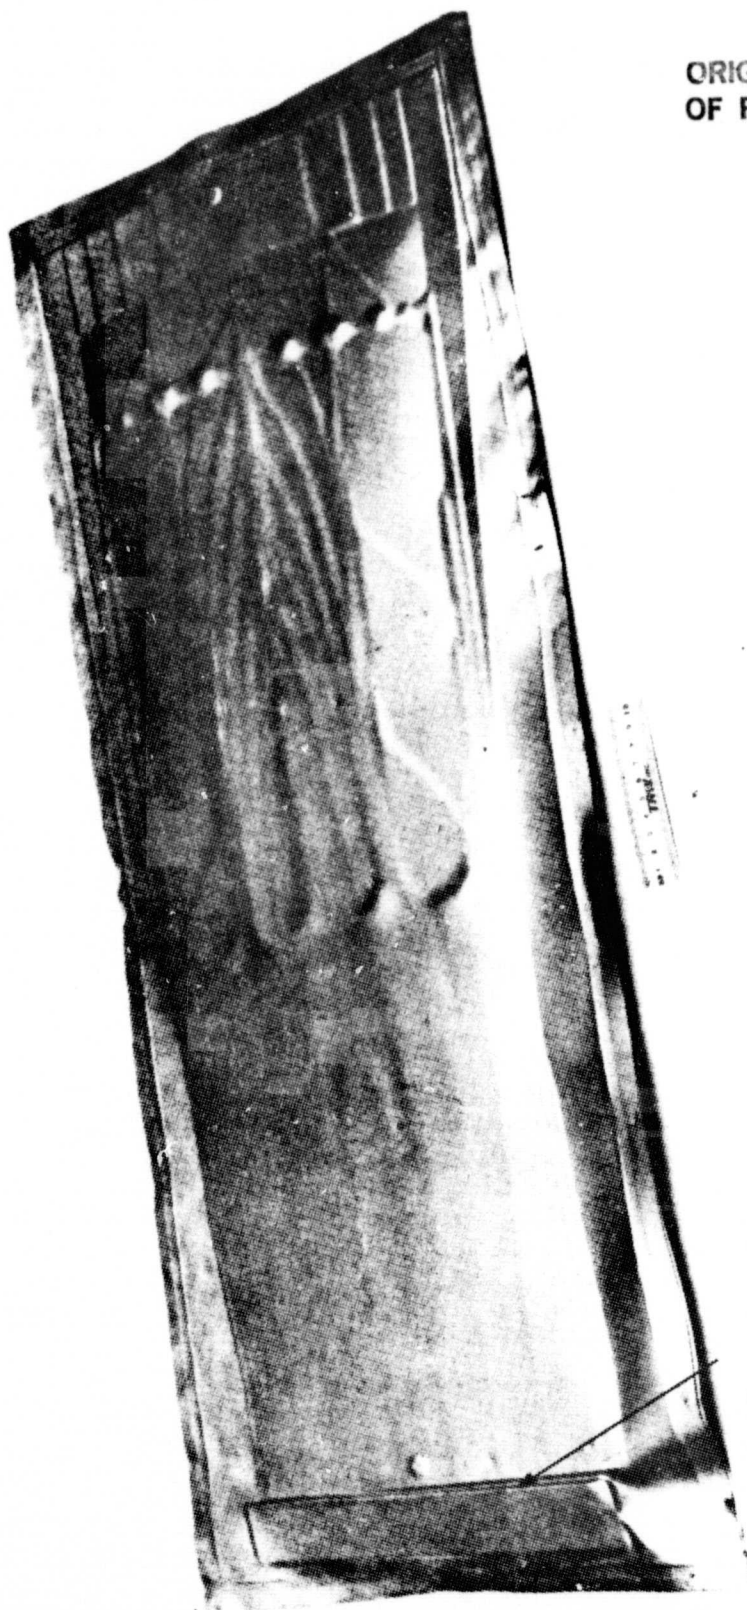
Surface Tears

Figure 81. As-HIP Blade 3. Surface Tears Were Found Along the Edge
Noted in the Figure.

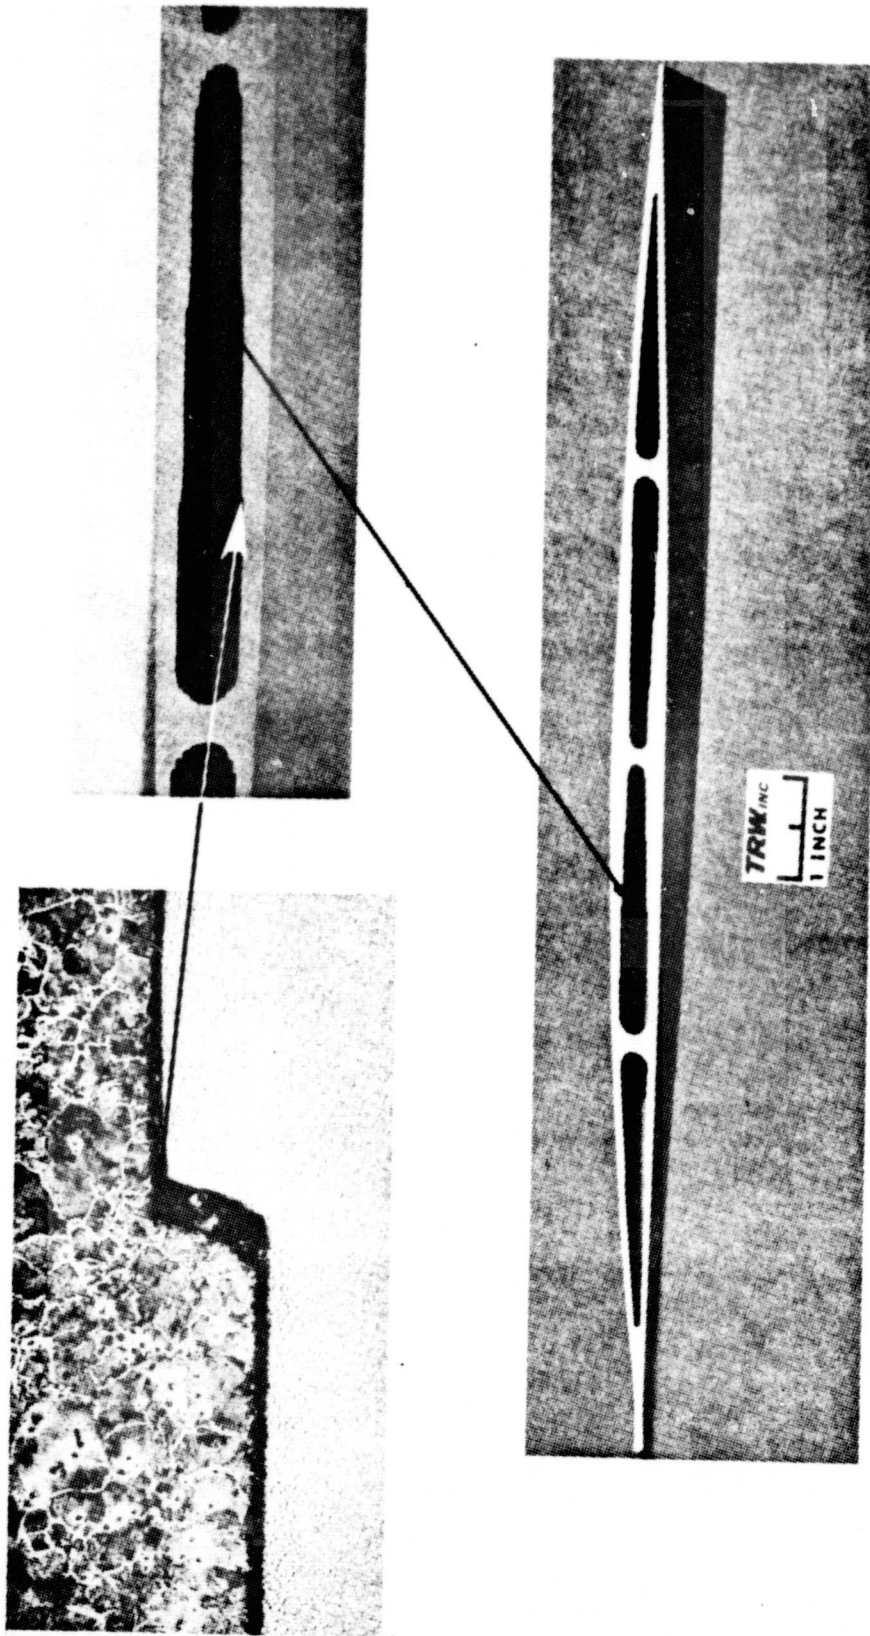
Figure 97. Section AF-AF of Blade 4 With Core Removed and Typical Internal Wall Surface Condition.
